Turbine Generators: a Recipe For a Very Large Fire

New Research

Electrifies Industry

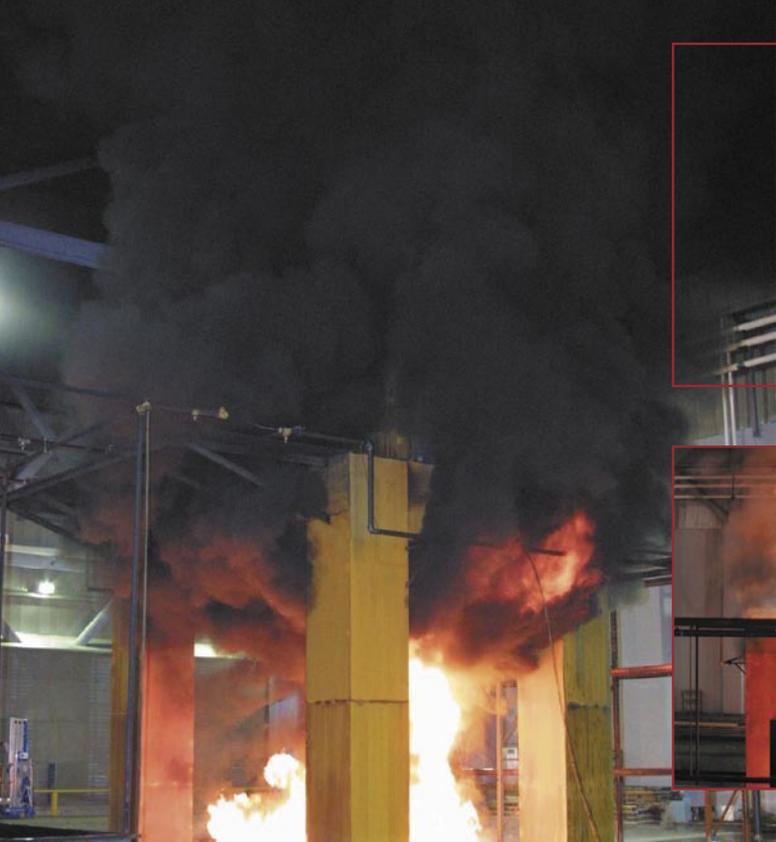
Three types of fires—spray, pool and three-dimensional spill—are associated with turbine generator hazards.

- Spray fires
- Pool fires
- Three-dimensional spill fires

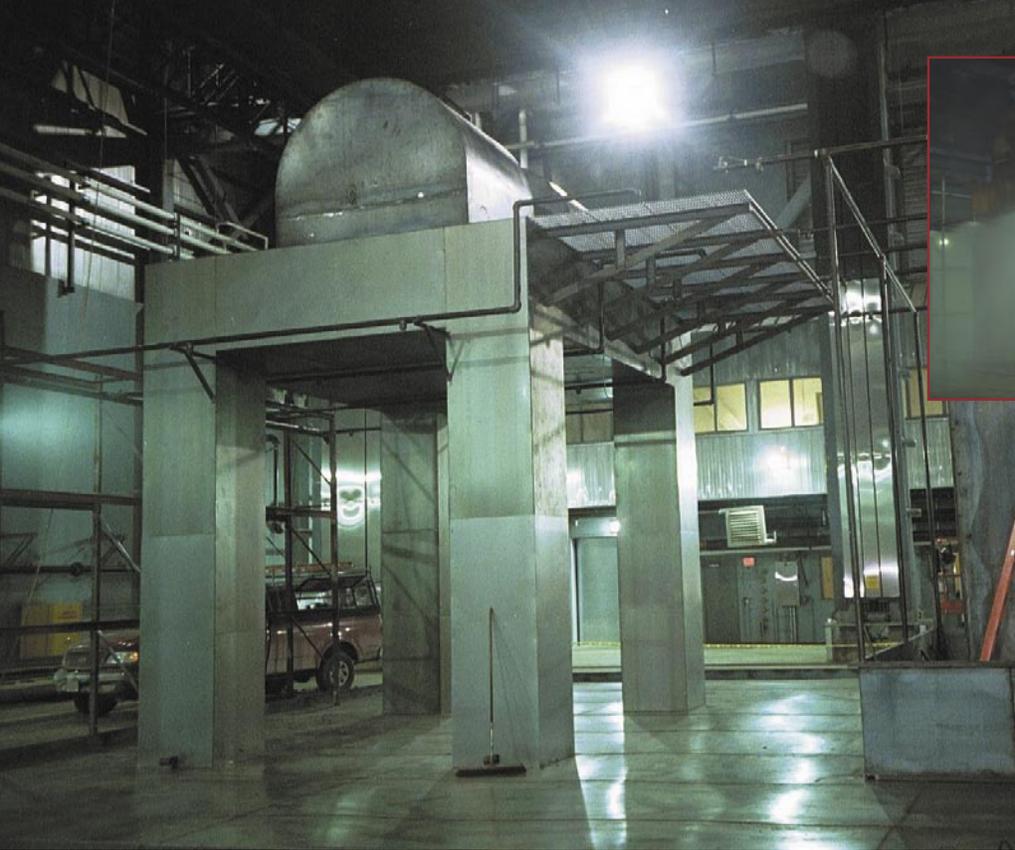
The turbine-hall mock-up was fabricated from steel, rather than the traditional concrete, to make it more “portable.”

The turbine-hall mock-up was fabricated from steel, though an actual turbine pedestal or foundation would typically be constructed from concrete; however, the FM Global mock-up needed to be at least somewhat “portable.” The pedestal alone measured 15-ft. wide x 20-ft. long x 18-ft. high (4.6-m wide x 6-m long x 5.5-m high), with a 7.5-ft. (2.3-m) grated walkway extending along one edge. To prevent deformation during fire testing, the pedestal was equipped with a water-cooling system consisting of water flowing through pipes in the pedestal legs.

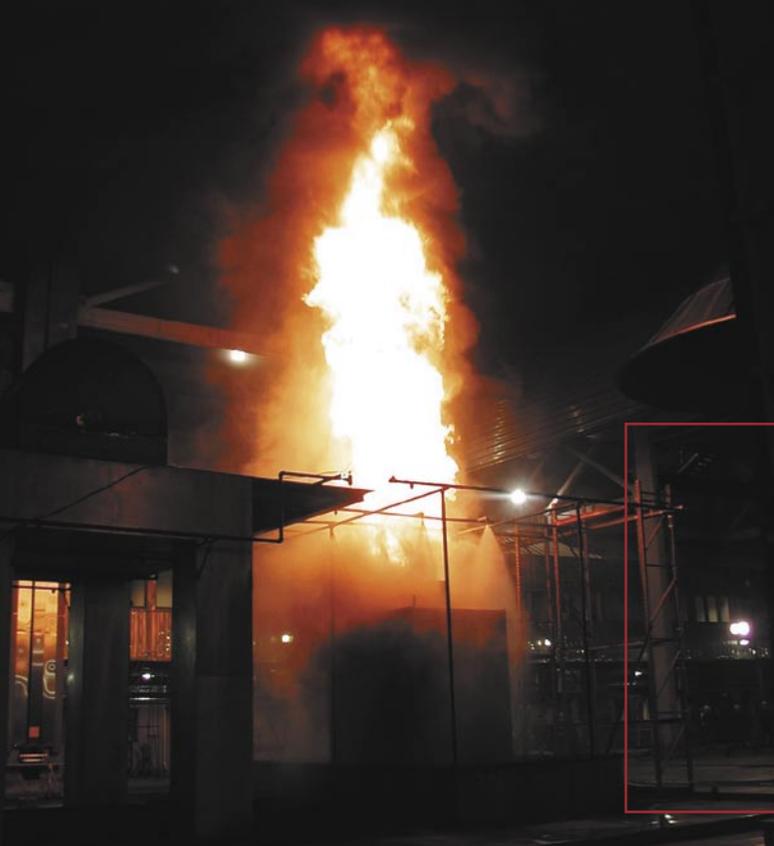
Turbine fire tests maximized resources in the Large Burn Laboratory at the Research Campus.

Even at the relatively low flow rate of 20 gpm (80 lpm), the researchers were surprised by the ferocity of some of the fires generated by the test apparatus. Some of the spray fires, in particular, generated heat-release-rate bursts of up to 40 MW or more. In fact, the testing required the collective capacity—and then some—of the entire FM Global burn laboratories and the 20-MW fire products collector.
