RESEARCH TECHNICAL REPORT

*Summary Report of Fire
Testing Involving Ignitable
Liquids – for NFPA 30*

(document prepared in support of code changes)

NFPA 30 Flammable and Combustible Liquid Code

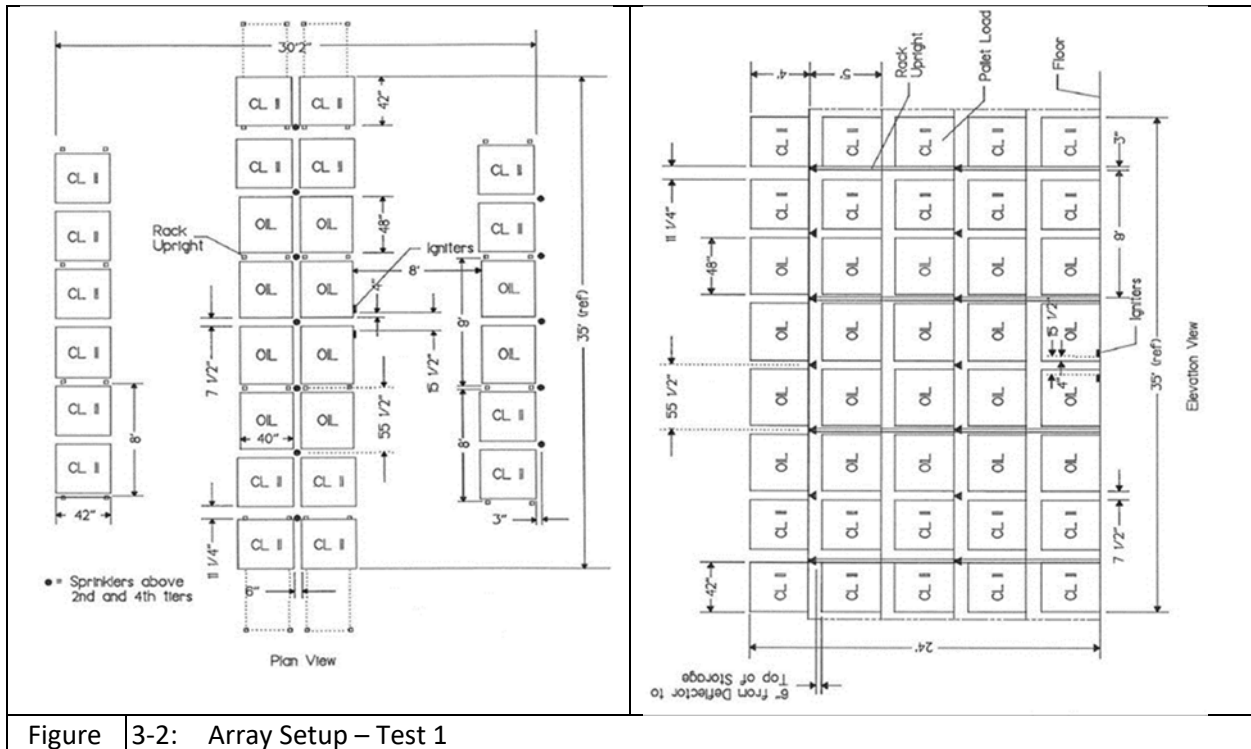
Figure 3-2: Array Setup – Test 1

Ignition was accomplished by means of two 3-in. diameter by 6-in. long cellucotton rolls each soaked in 8 oz of gasoline and enclosed in a polyethylene plastic bag. In Tests 1 and 2 they were located on the east face of the main array bordering the center transverse flue space (Figure 3-2 and 3-3). In the other tests they were located in the central transverse flue space, close to the east face of the main array (Figure 3-4 and 3-5).

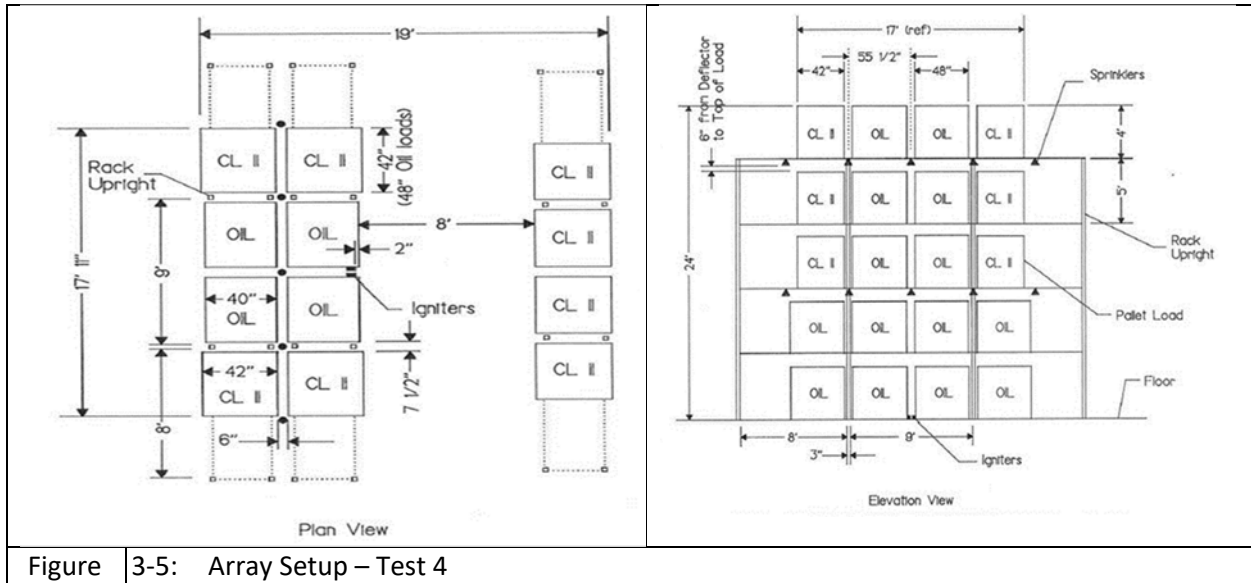
Figure 3-5: Array Setup – Test 4

Following a review of the three previous tests, the array size was again changed. The length was shortened and the west target omitted. The main array contained 28 pallet loads of oil (30,500 lb) and 12 of triwall cartons. The east target contained only triwalls. The entire 60 load array contained about 35,000 lb of combustibles. The percent of combustibles in the oil loads was the same as in Test 3. Overall array dimensions were about 18 ft long, 19 ft wide and 23 ft high. Otherwise, the setup was the same as that of Test 3 (Figure 3-5).

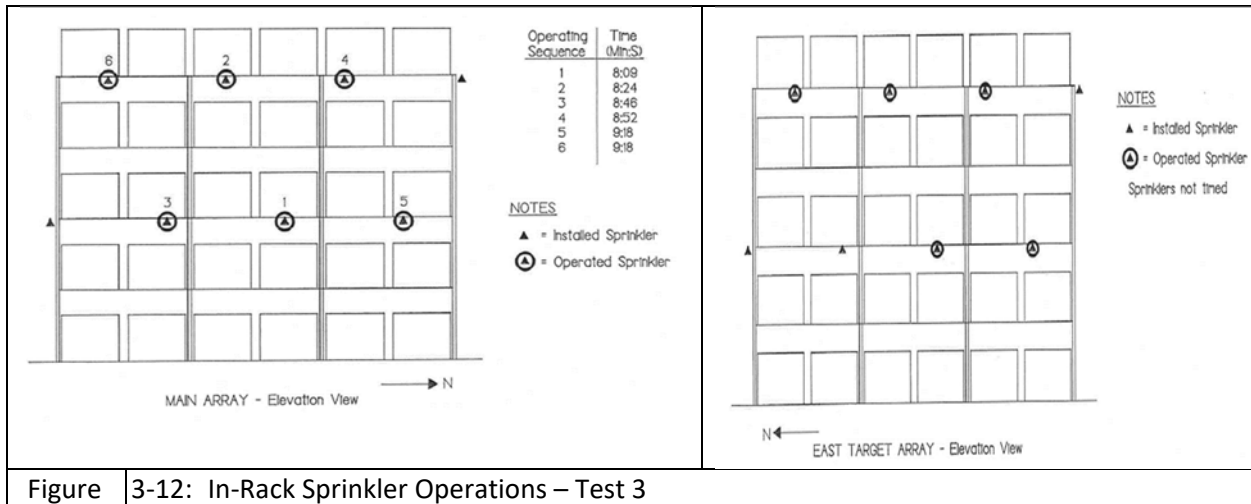
Figure 3-12: In-Rack Sprinkler Operations – Test 3

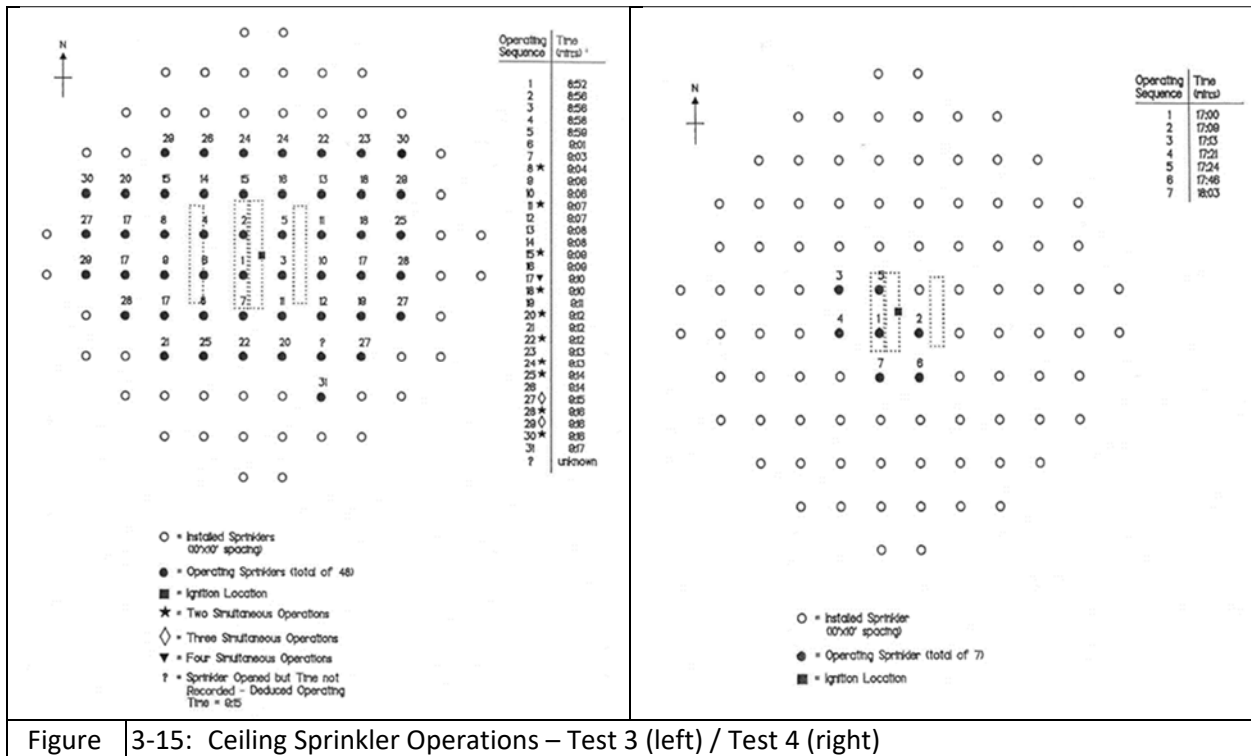
Figure 3-15: Ceiling Sprinkler Operations – Test 3 (left) / Test 4 (right)

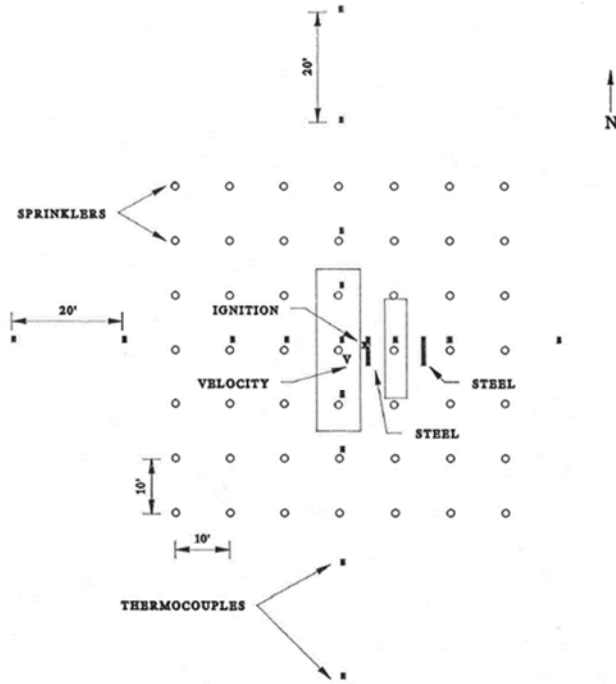
Figure 4. Plan View of Test Instrumentation - Main Array Centered Under One Sprinkler.

Figure 3-25: Plan View of Test Instrumentation – Main Array Centered Under One Sprinkler

The instrumentation used in these tests was designed to assist in making the determination of sprinkler effectiveness in fire suppression or control. Instrument locations used in these tests are shown in Figures 3-25 and 3-26.

Test instrumentation included: 1) thermocouples for making ceiling gas temperature measurements at 6.5 in. (165 mm) down from the ceiling over ignition and other selected locations over the test area; 2) 4 ft-long (1.2 m) sections of steel angle, nominally 2 in. x 2 in. x 1/4 in. thick, instrumented with thermocouples and installed at the ceiling over the center of the main array to assess potential damage to ceiling structural steel members; and 3) electrical circuits wired to the sprinklers and monitored by the data acquisition computer system to record sprinkler actuation times.

Two sections of steel angle were used in each test. The steel was oriented in the north-south direction, aligned with the longitudinal flue of the main array. When the array was centered directly below a sprinkler, one section of steel was 5 ft (1.5 m) east from directly over the main array. The second steel section was an additional 10 ft (3 m) east. When the main array was centered below two sprinklers, one steel section was directly over the longitudinal flue of the main array with the second section 10 ft (3 m) east.

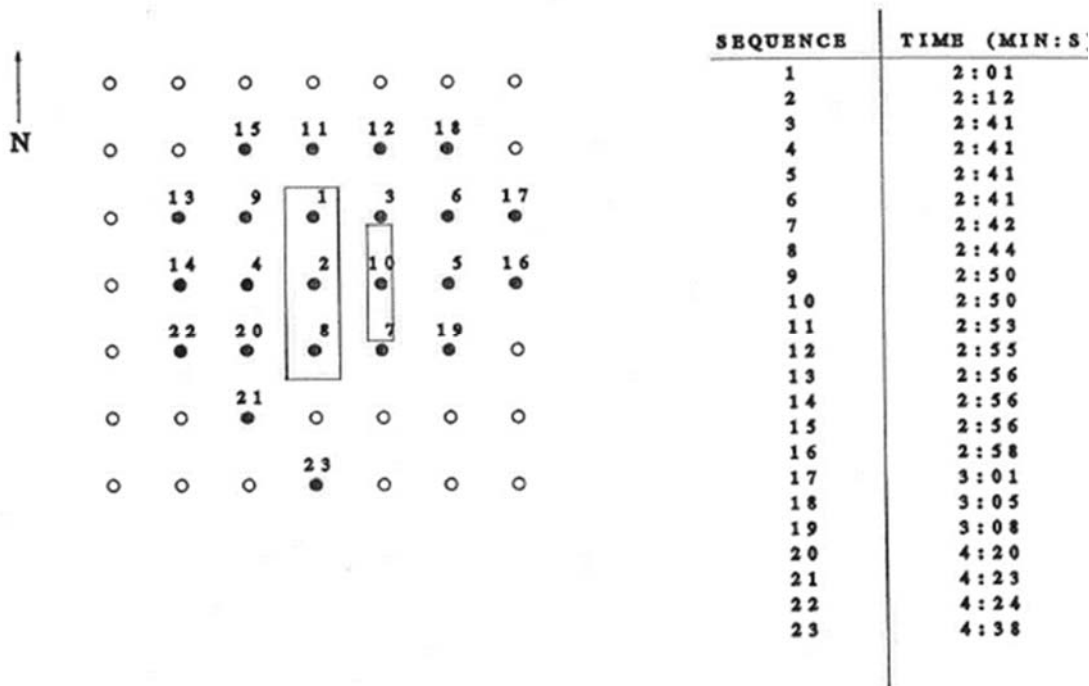
Figure 3-27: Sprinkler Actuation Sequence – Test 2

The first sprinkler to actuate was 5 ft (1.5 m) north over the center of the main array and this sprinkler actuated at 2 min 1 s after ignition. The flames remained at the ceiling and at 2 min 12 s the second sprinkler closest over ignition actuated. The fire was not immediately suppressed and flames remained at the ceiling.

At 2 min 30 s flames on the east face of the main array were almost spanning the 4 ft (1.2 m) aisle to the target array. Four additional sprinklers actuated at 2 min 41 s; one of these sprinklers was over the target array. The target array ignited at 2 min 44 s.

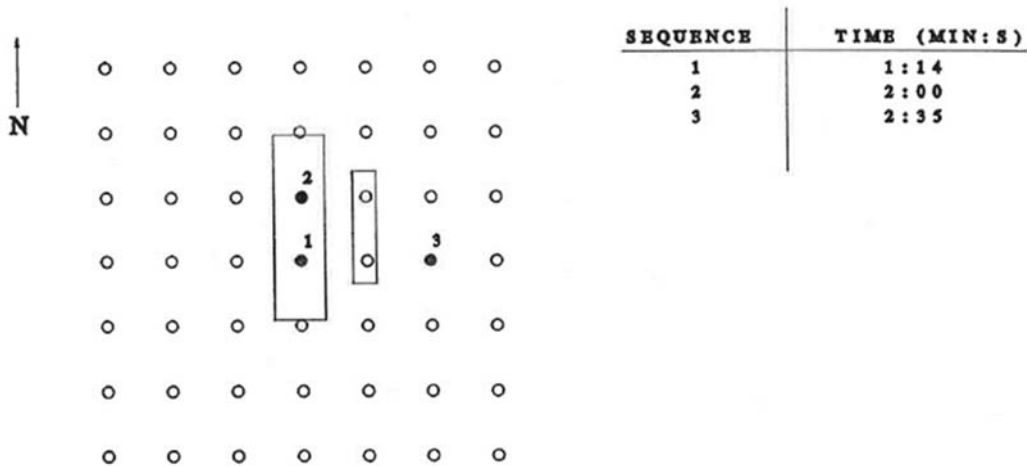
Figure 3-32: Sprinkler Actuation Sequence – Test 4

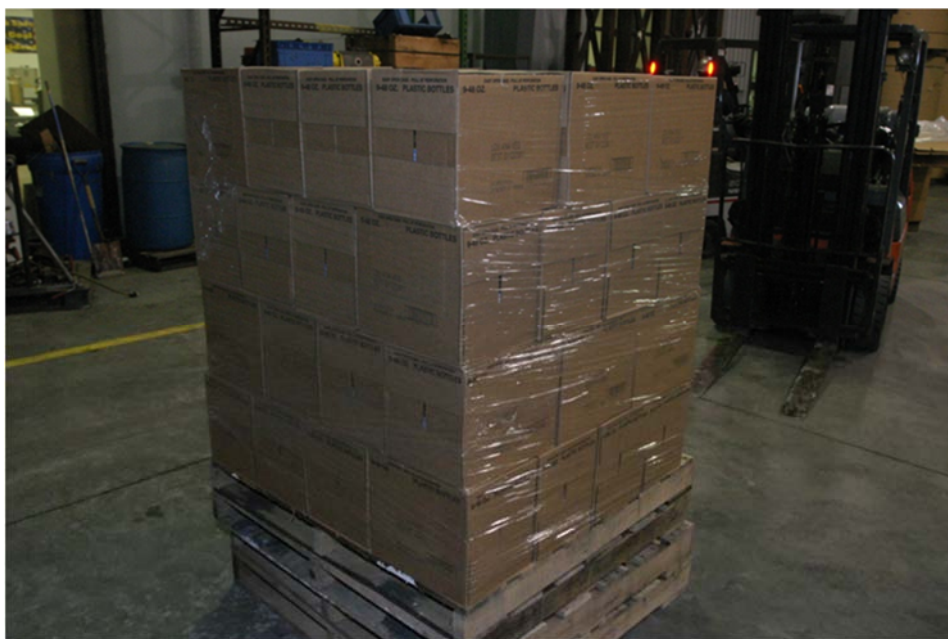
Figure 3-44: Photo of Cartoned Soybean Oil on Pallet

The commodity was cartoned, soybean oil, with a closed cup flashpoint of 505°F (263°C). The soybean oil was supplied in 48 oz. (1.4 L) plastic bottles, stored in corrugated cartons. Nine bottles were stored per carton and there were 52 cartons per pallet. A layer of stretch wrap held the commodity on the pallet. A photo of the commodity is provided in Figure 3-44 (extra pallets are not part of the commodity).

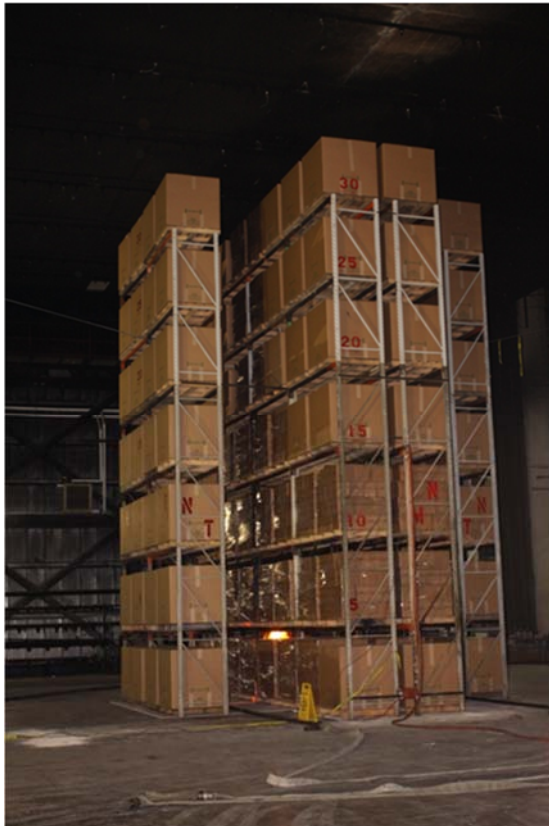
Figure 3-45: Photo of the Test Array 30 s After Ignition)

Nominal 6 in. (12.7 cm) flues were provided throughout the main and target arrays.

A photo of the test array is provided in Figure 3-45.

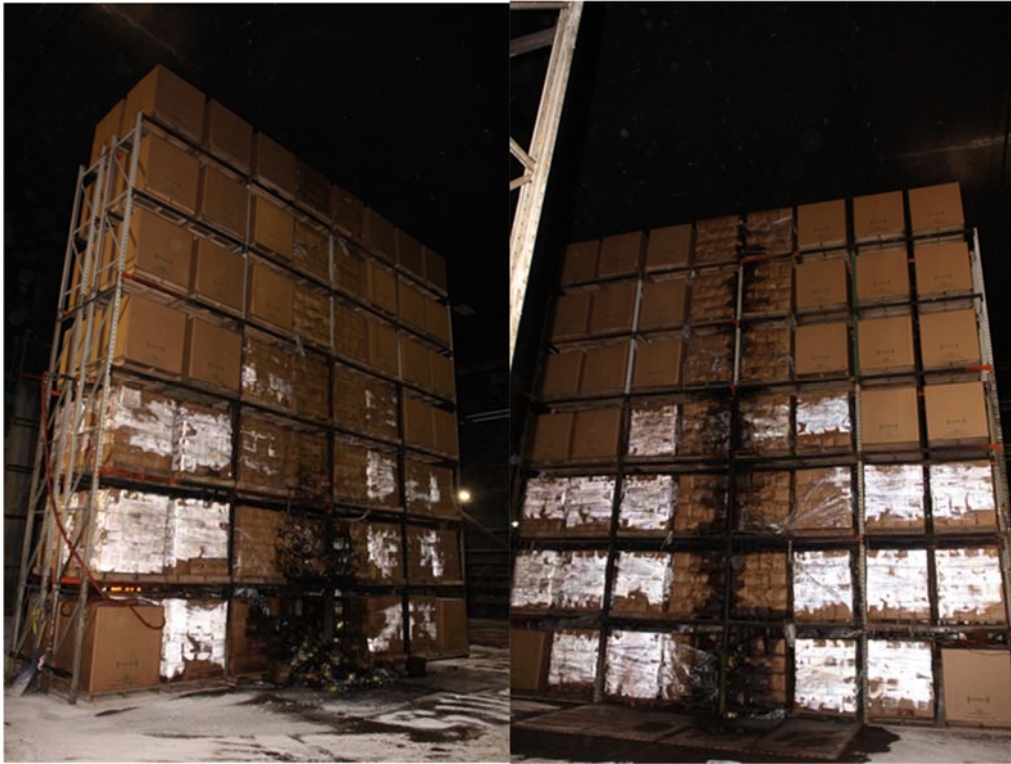
Figure 3-46: Post-test Photos of Test Array (West face on Left)

Post test observations showed that the fire spread through the main array had been contained by the combination of ceiling and in-rack sprinklers. The fire did jump to the west target array during the test, but prior to a sprinkler operation over the west aisle. Upon operations of a sprinkler over that aisle, the fire was quickly suppressed on the face of both the main array and the target array. Photos of the post-test damage to the main array are provided in Figure 3-46.

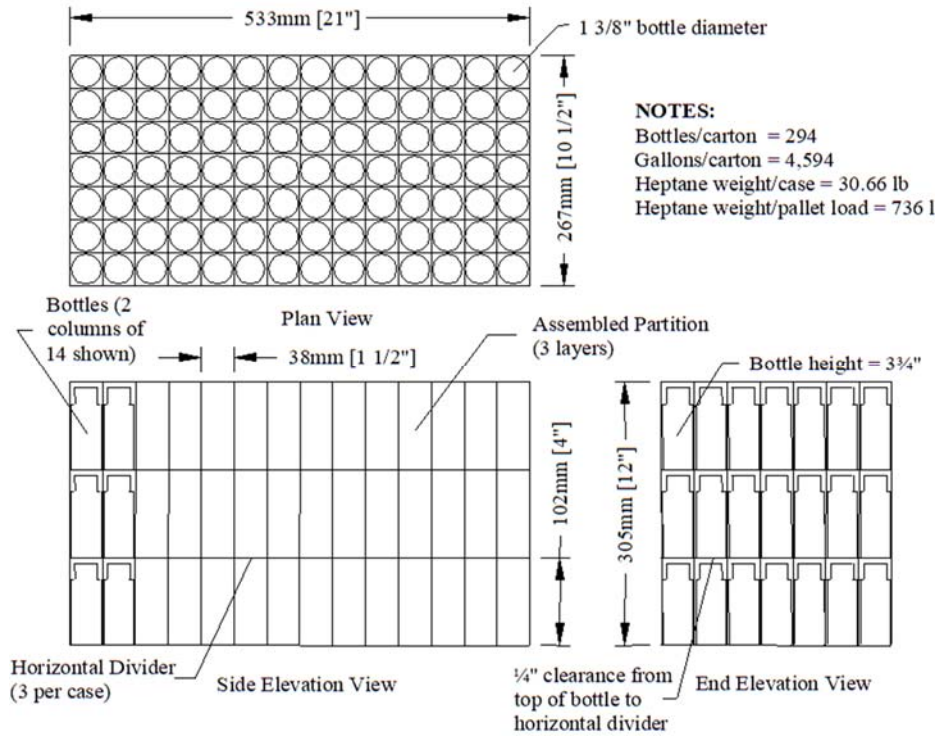
Figure 3-47: Single Carton of Commodity

A small bottle commodity was created for test purposes. The product consisted of 59 mL [2 fl oz] polyethylene bottles filled with heptane. The bottle shape and consequently the corrugated carton size were chosen to provide a good fit on a 1.1 m x 1.1 m [42-in. x 42-in.] pallet. The carton was designed to supply the required bottle wrapping by using thin cardboard vertical partitions and horizontal dividers. Figure 3-47 details the construction of a single carton of commodity.

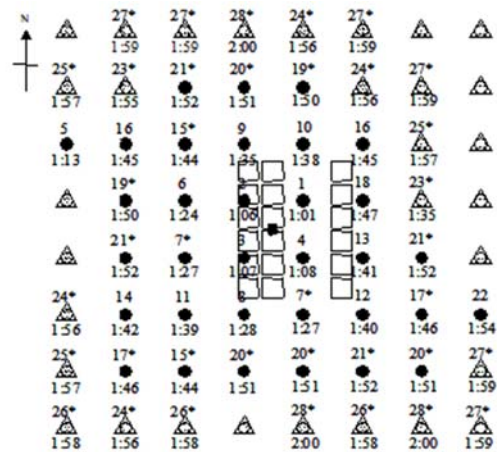
Operated Sprinklers: 33 by Test Termination; Total of 64.
 Simultaneous Operations: 7, 15, 16, 17, 19, 20, 21, 23, 24, 25, 26, 27, and 28.

Test Duration = 1:54

Figure 3-56: Ceiling Sprinkler Operations – Test 4

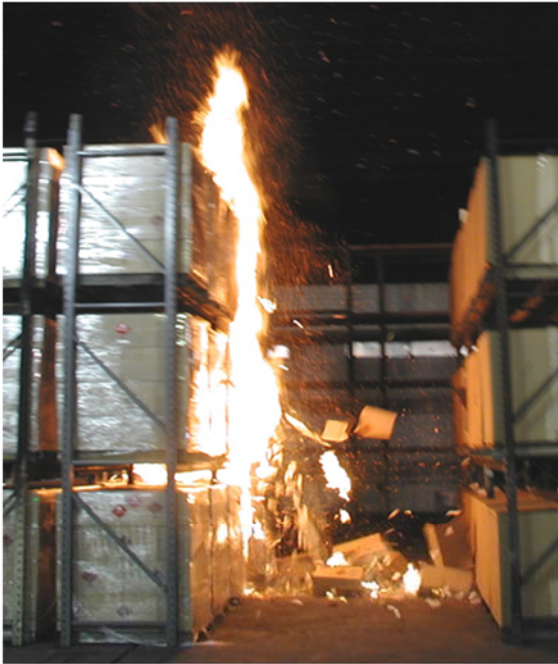
Major Explosion at 0:55; Flames on Ceiling (9.1 m [30 ft] High).

At 0:25 and 0:36 "pops" (muffled explosions) were heard. At 0:55 a significant explosion blew cartons and bottles from the array. From that time on, until the test termination at 1:54, numerous explosions occurred which blew cartons and bottles out either side of the array. Neither fireballs nor burning bottles were observed accompanying the explosions. Flames reached the array top (4.9 m [16 ft] high) at

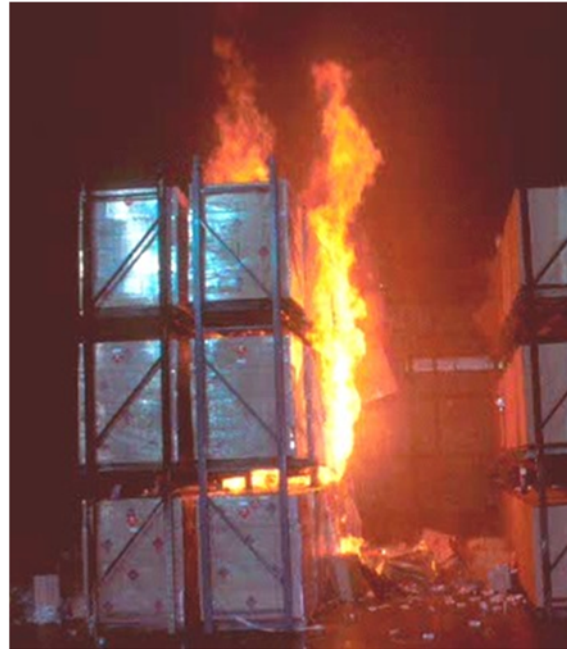
Fire Progress at 1:27, Eight Sprinklers Operating; Flames Steady on ceiling.

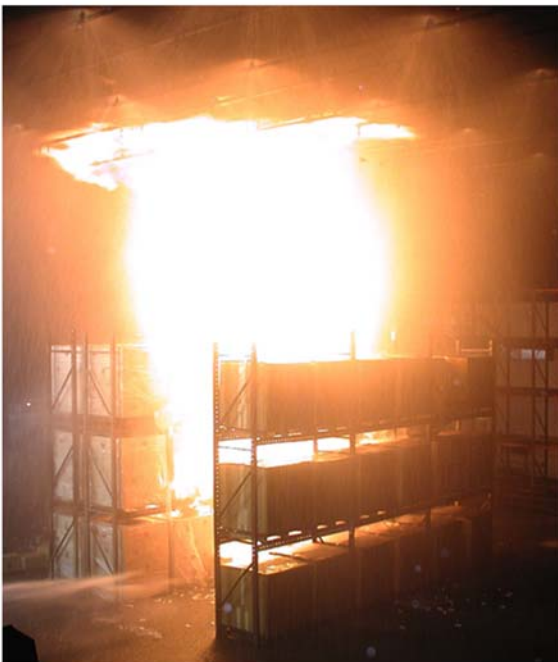
Fire Progress at 1:54 When Test Was Terminated. 33 Operating Sprinklers; Six Seconds Later 54 Sprinklers Were Open.

occurred followed shortly by operation of the first four sprinklers. Frequent explosions occurred between one minute and 1:54 when the test was terminated and flames were across the ceiling in about a 6.1 m [20 ft] diameter. The severity of the fire was well beyond expectations. However, there was no contribution by a pool fire since none was formed. Although the explosions were surprising, and many cartons and bottles were blown out of the racks as a result, it was determined that they had no significant effect on the fire's severity. Cartoned unexpanded plastics protection was inadequate to control a fire in the small bottle commodity.

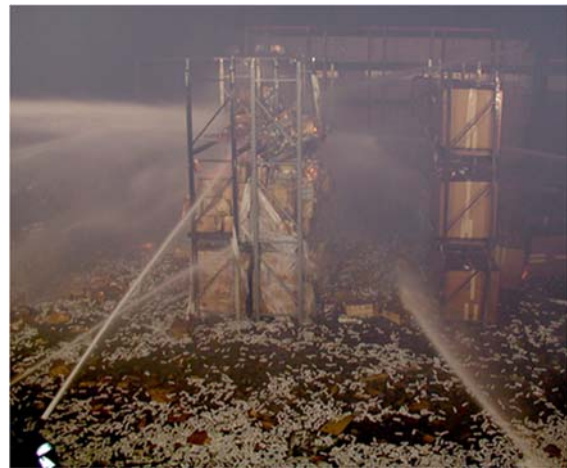
Extinguishment Efforts at About 45 minutes. Note Residual Flaming and Many Bottles in Debris.

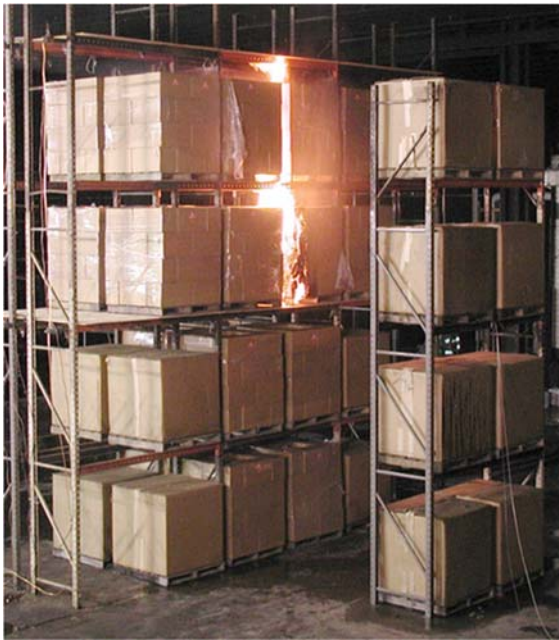
Fire Development at 1:57 Two Seconds Prior to Initial In-rack Sprinkler Operation.

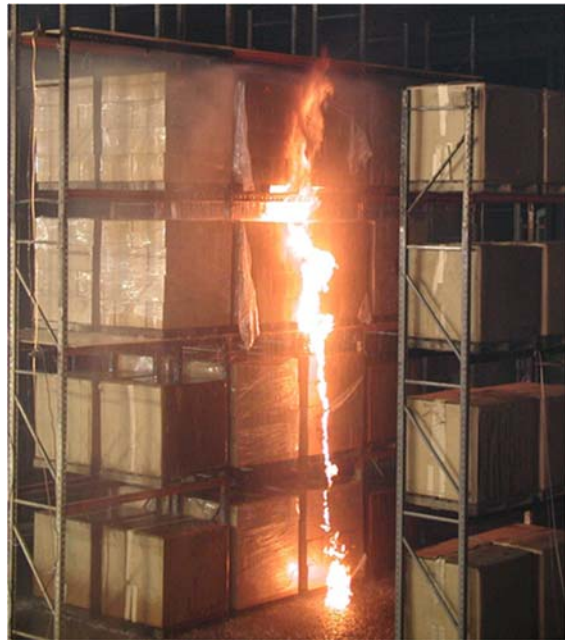
Fire Progress at 4:19, Final Total of Three In-rack Sprinklers Operating.

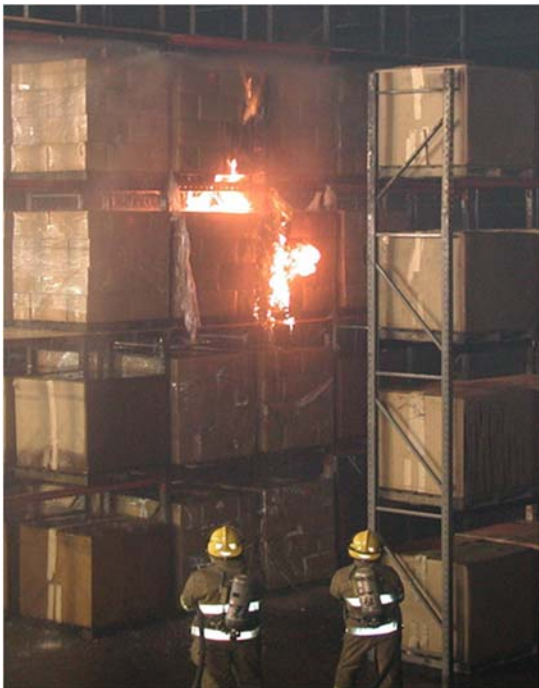
Fire Confinement at about Test Conclusion (16:00)

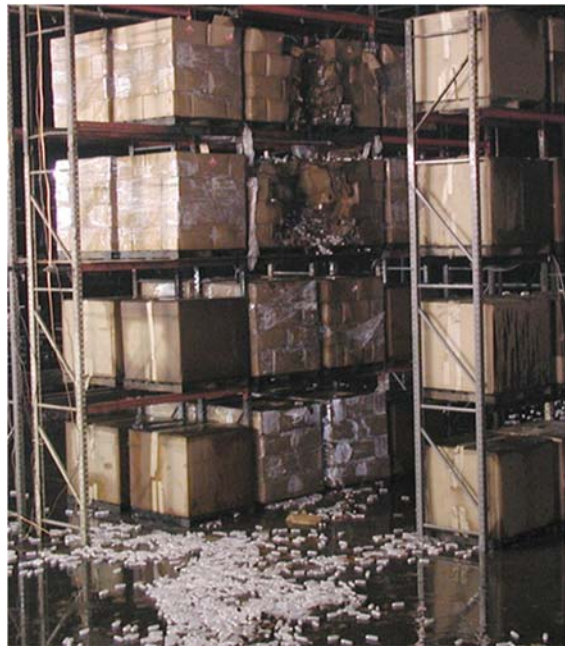
Damage

Figure 3-61: Test 5

Commodity salvaged from the previous test was used to create a higher storage array for this test. A combination of in-rack and ceiling sprinklers was used in order to determine an adequate protection for the small bottle commodity. Ignition was at the base of the third level close to the array east face. Fire development was such that flames were licking at sprinklers under the horizontal barrier over ignition at 1:57. Two seconds later the two adjacent face sprinklers opened and flames were reduced from about 3.4 to 1.5 m [11 to 5 ft] high. By about 6 minutes the fire appeared to be burning at a steady rate. Flames occasionally licked above the top barrier but fire was contained to the two ignition loads and the two immediately above them. A total of 3 in-rack and no ceiling sprinklers had operated by test conclusion at 16:00. Selected ceiling temperature data is provided in Figures 3-53 and 3-55. The fire chronology is provided in Section 3.4.7. In-rack sprinkler operations are shown in Figure 3-57. The extent of fire damage is shown in Figure 3-59. Figure 3-61 provides some select photographs from the test.

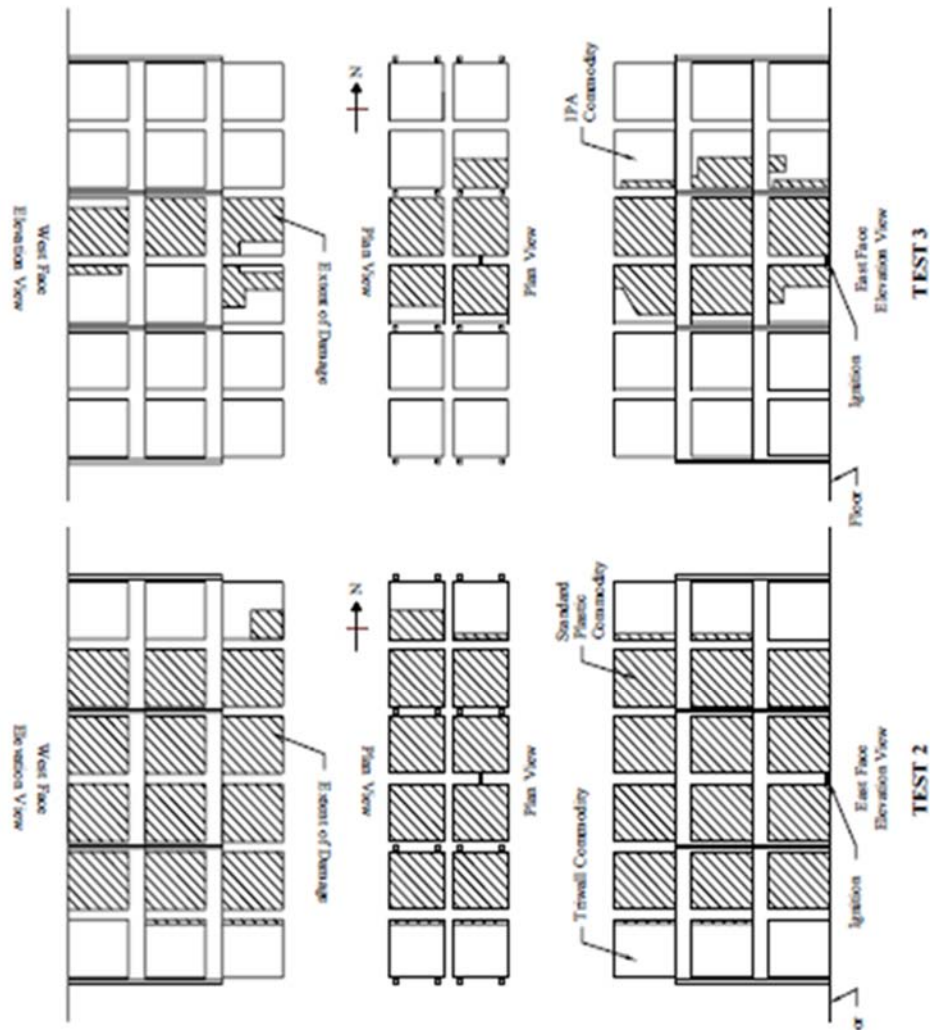
Figure 3-81: Extent of Damage for Test 2 and 3

The extent of fire damage and amount of commodity consumed are important indicators of fire severity and protection effectiveness. Comparing the two tests on this basis, it was found that the number of pallet loads involved in the fire was greater in Test 2 (Standard Cartoned Unexpanded Plastic Commodity) than in Test 3 (99% IPA). In none of the tests did the fire damage reach the ends of the array nor did the fire jump to the target array. These are both positive factors relating to the applied

protection. The total commodity consumption in Test 3 was approximately 5 times less than that consumed in Test 2. Figure 3-81 illustrates the extent of damage for both tests.

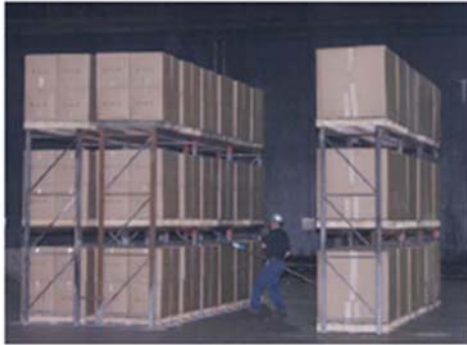
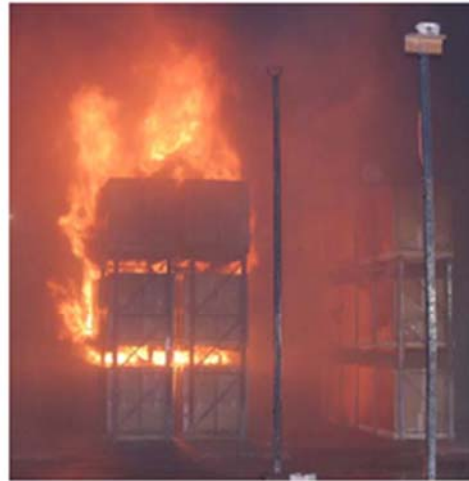
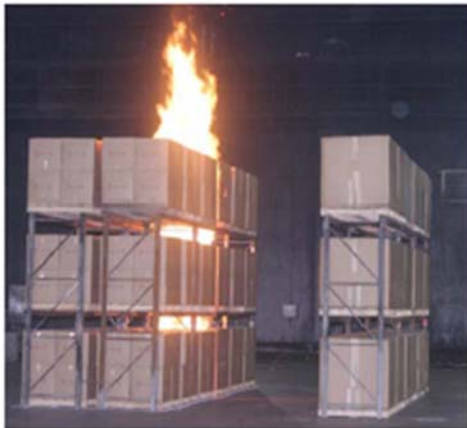
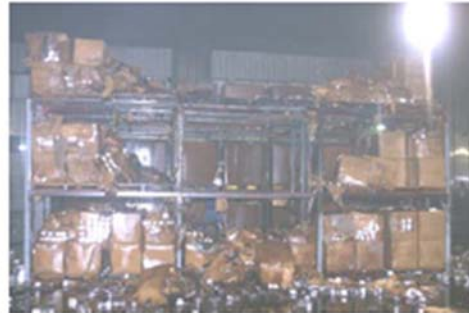
Figure 3-82: Test #2 Photographs

Array Setup

Fire Development at 2 min 40 sec

Fire Development at 44 sec

Post Test Damage

Test #2 caused the activation of 26 sprinklers and Test #3 (99% IPA) operated a total of 19 sprinklers. The total amount of sprinkler water used in the 1st 20 minutes of the test for each test is as follows: 27,210 gallons, and 19,410 gallons for Test #2, and #3, respectively. The sprinkler operating times, sequence and location are illustrated in Figure 3-80 for Tests #2, and #3. Fire chronologies from both tests are shown in Tables 3-11 and 3-12. Selected photographs from each test are shown in Figures 3-82 and 3-83.

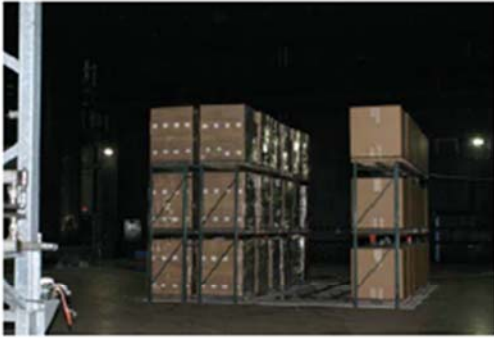
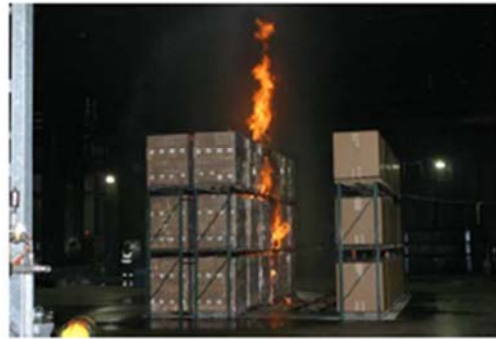
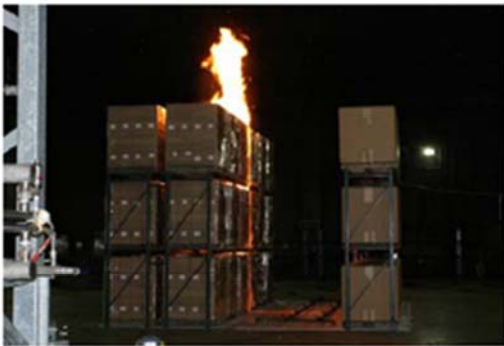
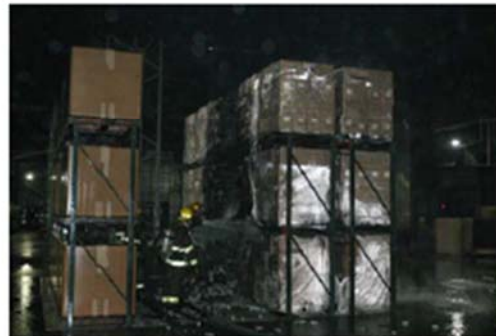
Figure 3-83: Test #3 Photographs

Array Setup

Fire Development at 2 min 40 sec

Fire Development at 44 sec

Post Test Damage

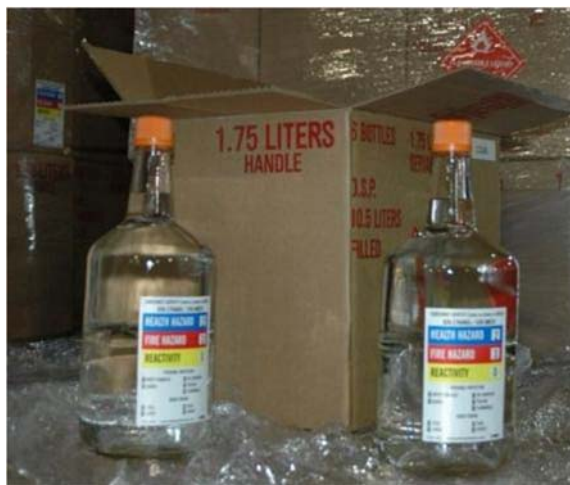
Figure 3-131: Photo of 1.75 L (59 fl. oz.) Glass Bottles

The products and materials that made up the test commodity were secured from outside vendors to the distilled spirits industry. The 1.75 L (59 fl. oz.) glass containers were 305 mm (12 in.) high, 125 mm (5 in.) diameter with a formed glass handle (Figure 3-131).

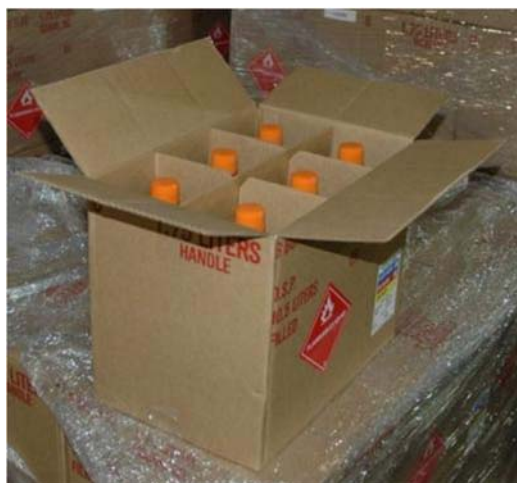
Figure 3-132: Photo of Bottles Loaded Six per Carton

The bottles were packaged in industry-standard 394 mm x 267 mm x 324 mm high (15 ½ in. x 10 ½ in. by 12 ¾ in. high) corrugated paper cartons. Each carton contained six 1.75 L (59 fl. oz.) glass bottles (Figure 3-132).

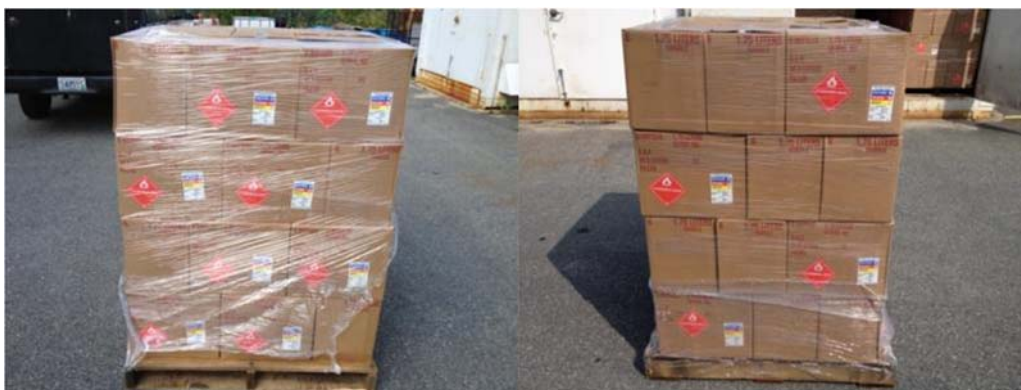
Figure 3-133: Photos of Loading of Cartons on Pallets

Thirty-six cartons were arranged in four layers (nine per layer) on the standard FM Global 1.07 m x 1.07 m (42 in. x 42 in.) two-way hardwood pallet. Each pallet-load was approximately 1.41 m (55 ½ in.) high. Due to the box dimensions and positioning on the pallet, the cartons were flush in one direction but did not cover the entire pallet in the other direction. This resulted in a roughly 152 mm (6 in.) difference between the pallet separation and the carton separation (i.e., a 152 mm [6 in.] flue between pallets resulted in a 305 mm [12 in.] flue between cartons). Figure 3-133 presents a photo of the pallet loads from each side. Note the lip created by the pallet on the right-hand photo.

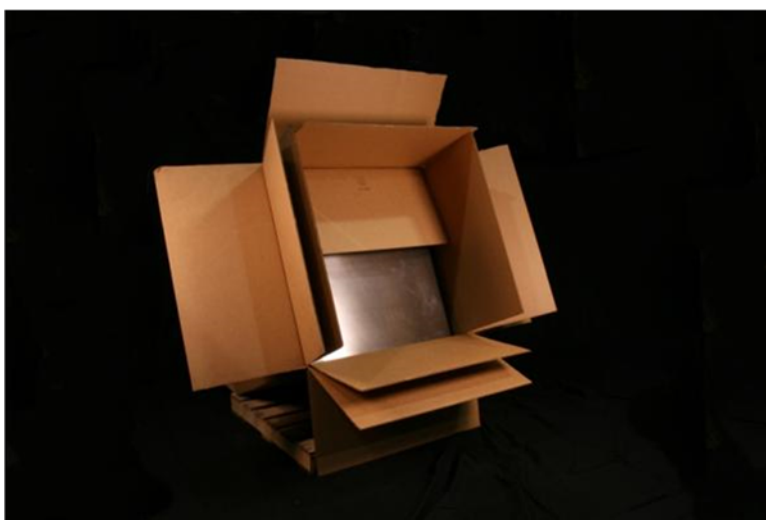
Figure 3-134: Photo of FM Global Standard Class 2 Commodity

The FM Global Standard Class 2 commodity consists of three double-wall corrugated paper cartons. The dimensions for the inner, middle, and outer box are 1.02 m x 1.02 m x 0.96 m (40.3 in. x 40.3 in. x 37.8 in.), 1.04 m x 1.04 m x 0.99 m (41.0 in. x 41.0 in. x 39.1 in.), and 1.06 m x 1.06 m x 1.05 m (41.8 in. x 41.8 in. x 41.5 in.), respectively. Inside the cartons is a five-sided sheet metal liner, representing a non-combustible content. The cartoned liner is supported on an ordinary, two-way, slatted deck, hardwood pallet, measuring 1.07 m x 1.07 m x 13 cm (42 in. x 42 in. x 5 in.). A photo of the Class 2 commodity is provided in Figure 3-134.

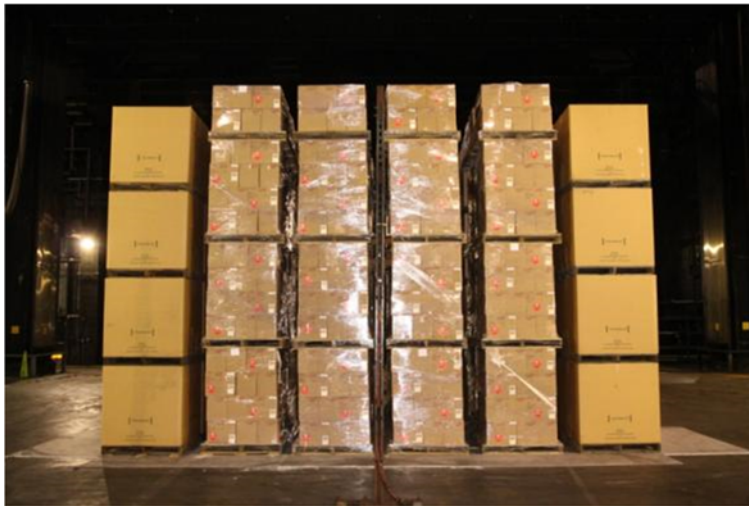
Figure 3-137: Photo of Front of Test Array (Tests 1-3)

Front and side views of the test array are provided in Figure 3-137 and Figure 3-138, respectively.

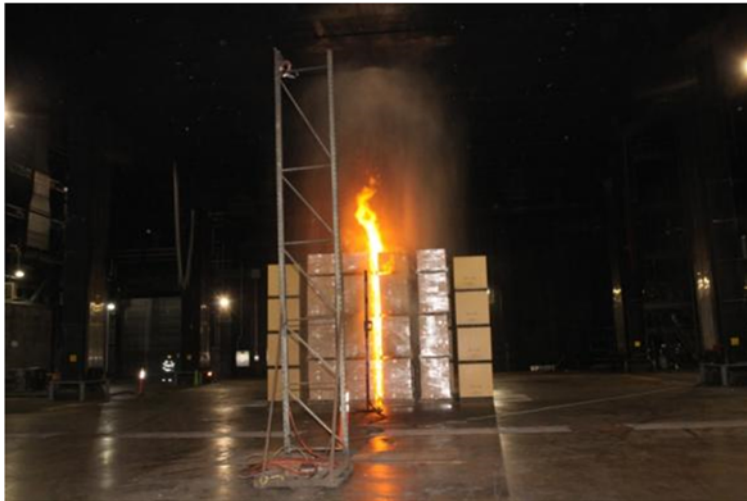
Figure 3-144: 1st Sprinkler Operation (1 min 19 s)

Upon ignition, flames traveled up the center longitudinal flue and reached the top of the array at 1 min. Flames were 3.0 m (10 ft) above the array, and the first sprinkler operated at 1 min 19 s (Figure 3-144). The sprinkler was very effective at reducing the fire severity and flames were below the top of the array

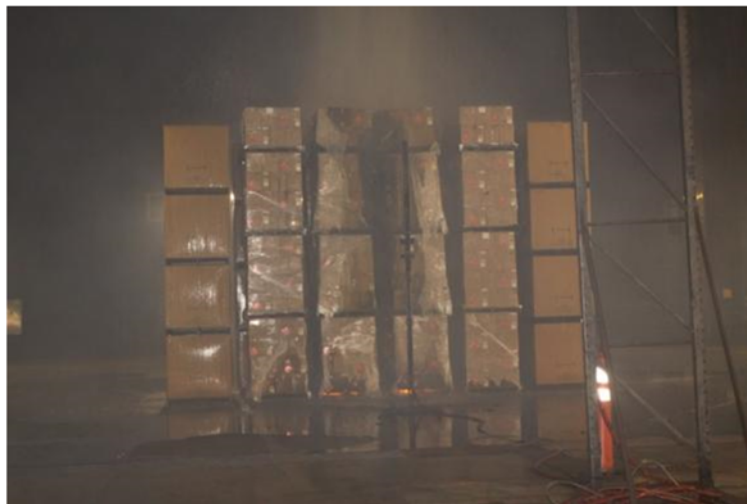
Figure 3-145: Stack Leaning and Small Pool Fire (5 min 30 s)

As the fire continued to burn within the array, glass bottles could be heard breaking as they dropped to the floor causing brief flare-ups in the flue spaces and contributing alcohol to the floor level pool fire. A consistent, small pool fire was present below the pallets of the array, but limited burning was observed in the stacks. As the bottles dropped from the array, the stacks on either side of ignition began to lose stability and were leaning against each other (Figure 3-145).

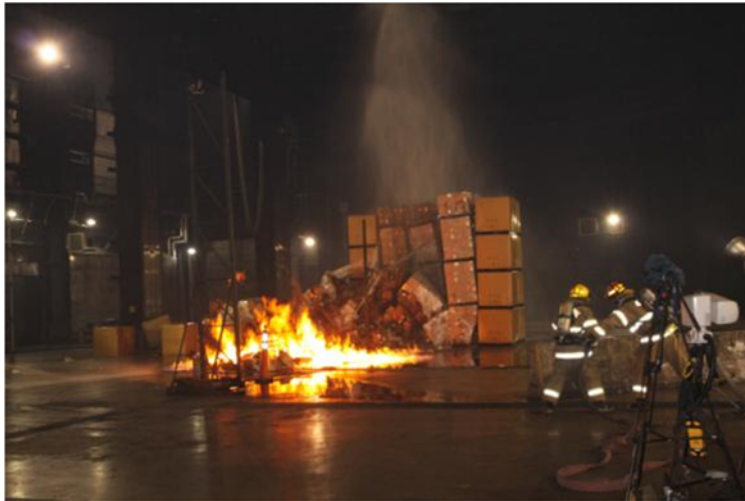
Figure 3-146: Array Collapse (20 min 36 s)

Over the next several minutes, glass continued to fall from the array, further reducing the stability of the stacks. At 19 min 54 s, the southernmost stacks collapsed forming large fires at floor level. At 20 min 34 s, additional commodity collapsed towards the west (Figure 3-146). These floor level fires operated two additional ceiling level sprinklers. The operating sprinklers were able to quickly reduce the fire severity in the collapsed commodity and by 25 min, the fires were mostly extinguished. During the remainder of

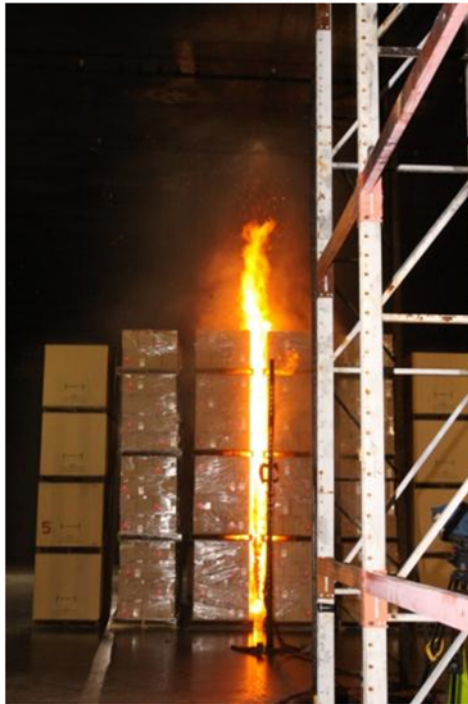
Figure 3-148: Test 2 - 1st Sprinkler Operation (1 min 12 s)

The flames traveled up the longitudinal flue and reached the top of the array at 1 min 6 s. The 1st sprinkler operated at 1 min 12 s and flames were 3.0 m (10 ft) above the array at the time the sprinkler operated (Figure 3-148). The sprinkler was able to knock the flames down but the fire persisted within the longitudinal flues and below the pallets of each tier. Glass bottles fell from the stacks as the cartons burned away and the pallet loads began to lean within the array at 2 min 25 s. The top of the stacks leaned in towards each other and completely blocked the longitudinal flue.

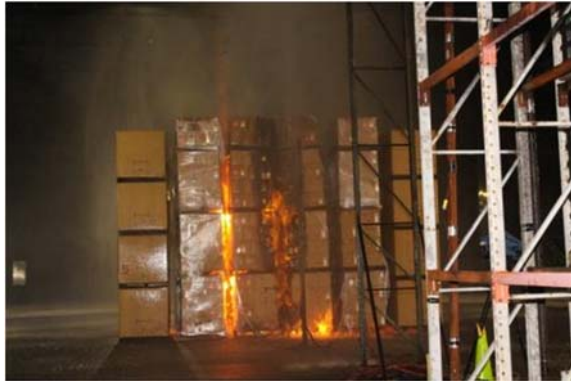
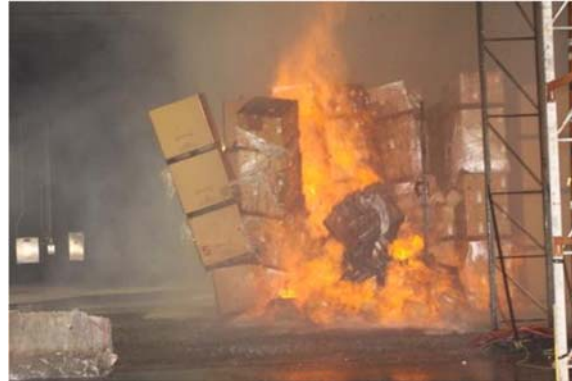
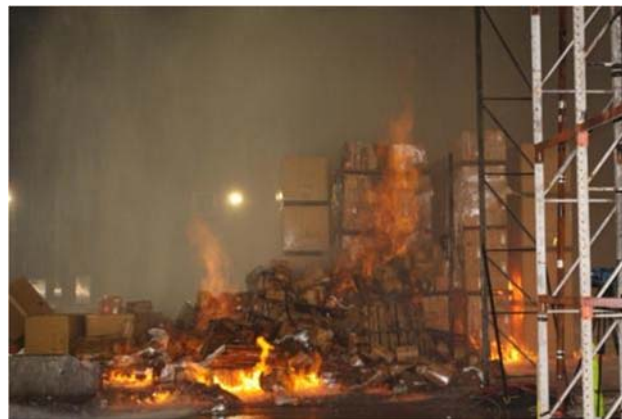
Figure 3-149: Test 2 – Array Collapse

At 5 min 15 s, four stacks of the test array collapsed towards the west (Figure 3-149). Collapsed commodity reached the western extent of the test pad, approximately 6.1 m (20 ft) from the array.

Shifting Array (4 min 22s)

Array Collapse (5 min 14 s)

Collapsed Material (5 min 50 s)

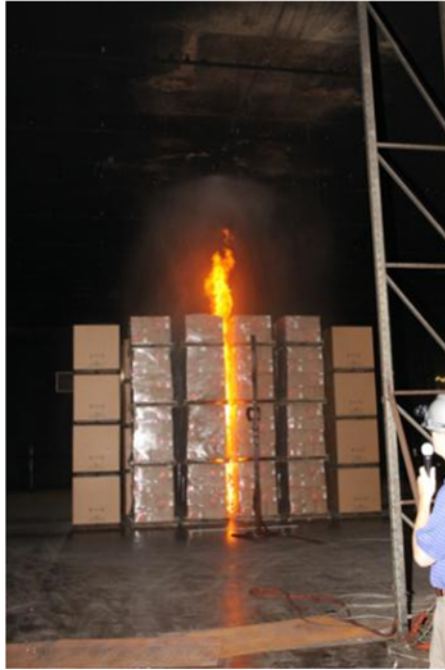
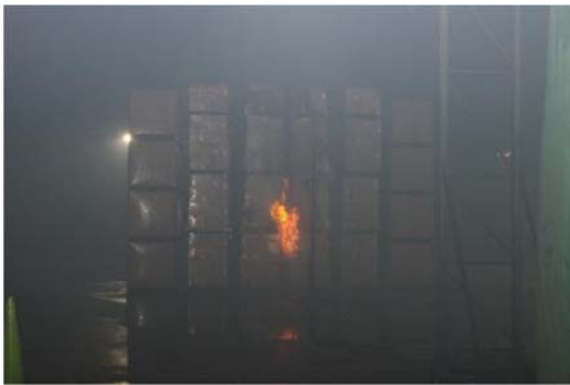
Figure 3-151: Test 3 Fire Progression

Upon ignition, the flames traveled up the longitudinal flue and reached the top of the array at 56 s. The 1st sprinkler operated at 1 min 4 s and flames were 1.8 m (6 ft) above the array at the time the sprinkler operated (Figure 3-151). The fire was knocked down below the top of the array but was still present in the longitudinal flue at 2 min 7 s. Glass bottle breakage was occurring throughout the test. The center stacks around ignition were leaning against each other by 3 min 31 s. Very small fires were present in the longitudinal flue and as glass bottles fell from the array, small flare-ups were caused from the breaking bottles. However, none of these contributed significantly to the fire severity. The breakage continued through to test termination, but no sustained fire was visible within the array. The test was terminated at 32 min.

1st Sprinkler Operation (1 min 4 s)

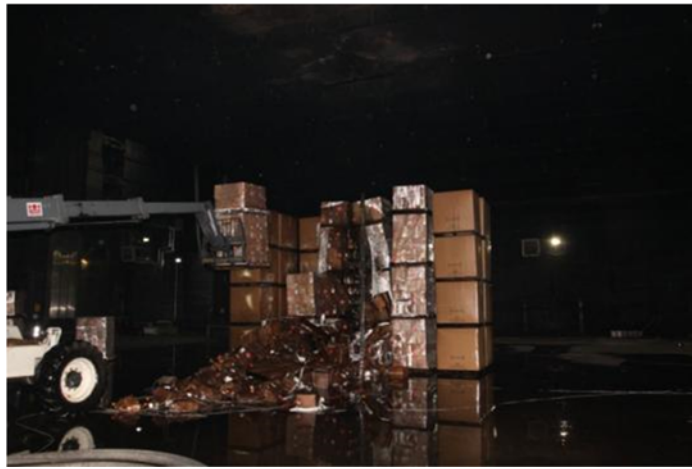
Figure 3-152: Test 3 - Array Collapse During Cleanup (Post Test)

During the test, one sprinkler operated and was able to control the fire. During the course of the test, a small fire remained in the longitudinal flue and glass bottles did fall from the array and break. However, none of the falling bottles created a sustained pool fire and the array did not collapse during the test. Stacks were leaning within the array at the time of test termination. Post test, the array did collapse as seen in Figure 3-152. The peak ceiling steel temperature was 34°C (93°F). The damage assessment from the test and the sprinkler operation pattern is provided in Figure 3-153.

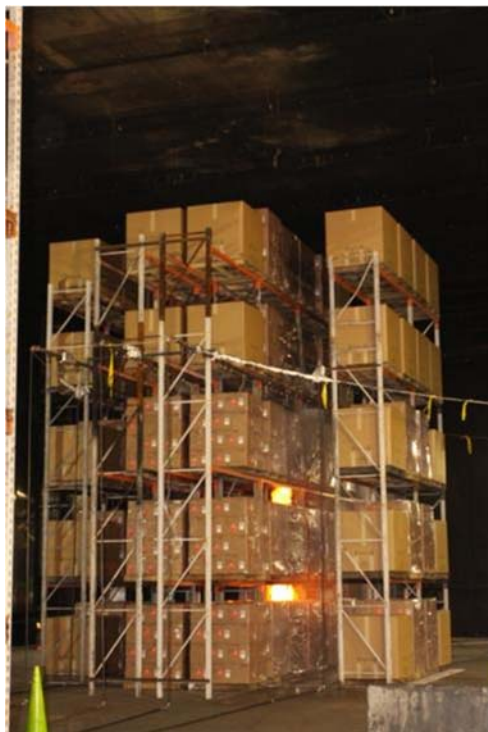
Figure 3-154: 52 s - 1st IRAS Operation

Upon ignition, the fire traveled up the center transverse flue of the array and was above the 1st tier at 24 s. Flames were just reaching the 3rd tier when the 1st in-rack sprinkler operated at 52 s (Figure 3-154). The IRAS reduced the fire intensity and at 1 min 41 s, flames were not observed above the 2nd tier level. During the test bottles fell from the array causing brief flare-ups. Some of these flare-ups sent flames into the second tier. At 3 min 8 s, one of these flare-ups operated a 2nd in-rack sprinkler in the longitudinal flue. At 5 min, no fire could be observed within the array and the test was terminated at 15 min.
