RESEARCH TECHNICAL REPORT

*Summary Report of Fire
Testing Involving Ignitable
Liquids – for NFPA 30*

(document prepared in support of code changes)

NFPA 30 Flammable and Combustible Liquid Code

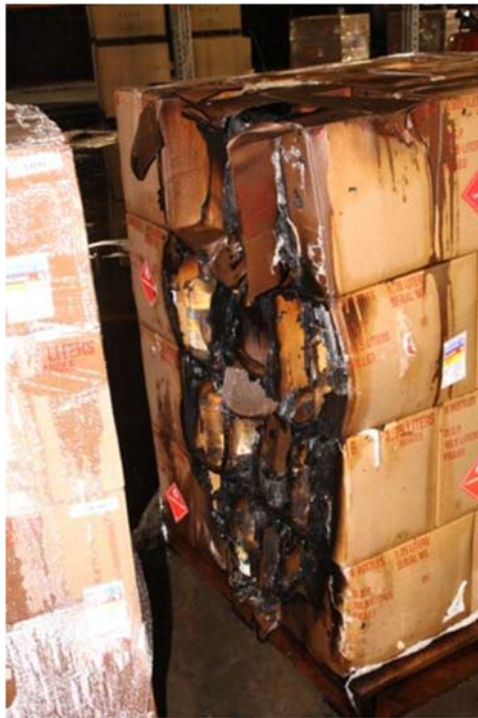
Figure 3-155: Post Test Damage to Commodity near Ignition Flue – Test 4

During the test, two in-rack sprinklers operated and were able to control the fire. No ceiling level sprinklers operated during the test. Damage within the array was primarily in the 1st and 2nd tier commodity along the face of the ignition flue. A photo of the typical damage observed is provided in Figure 3-155. The peak ceiling steel temperature was 31°C (87°F). The damage assessment from the test and the sprinkler operation pattern are provided in Figure 3-156 and a blown-up view of the damage area with operated in-rack sprinklers is provided in Figure 3-157.
